PERATION

GREENHOUSE

SCIENTIFIC DIRECTOR'S REPORT

ANNEX 3.2 U. S. NAVY STRUCTURES

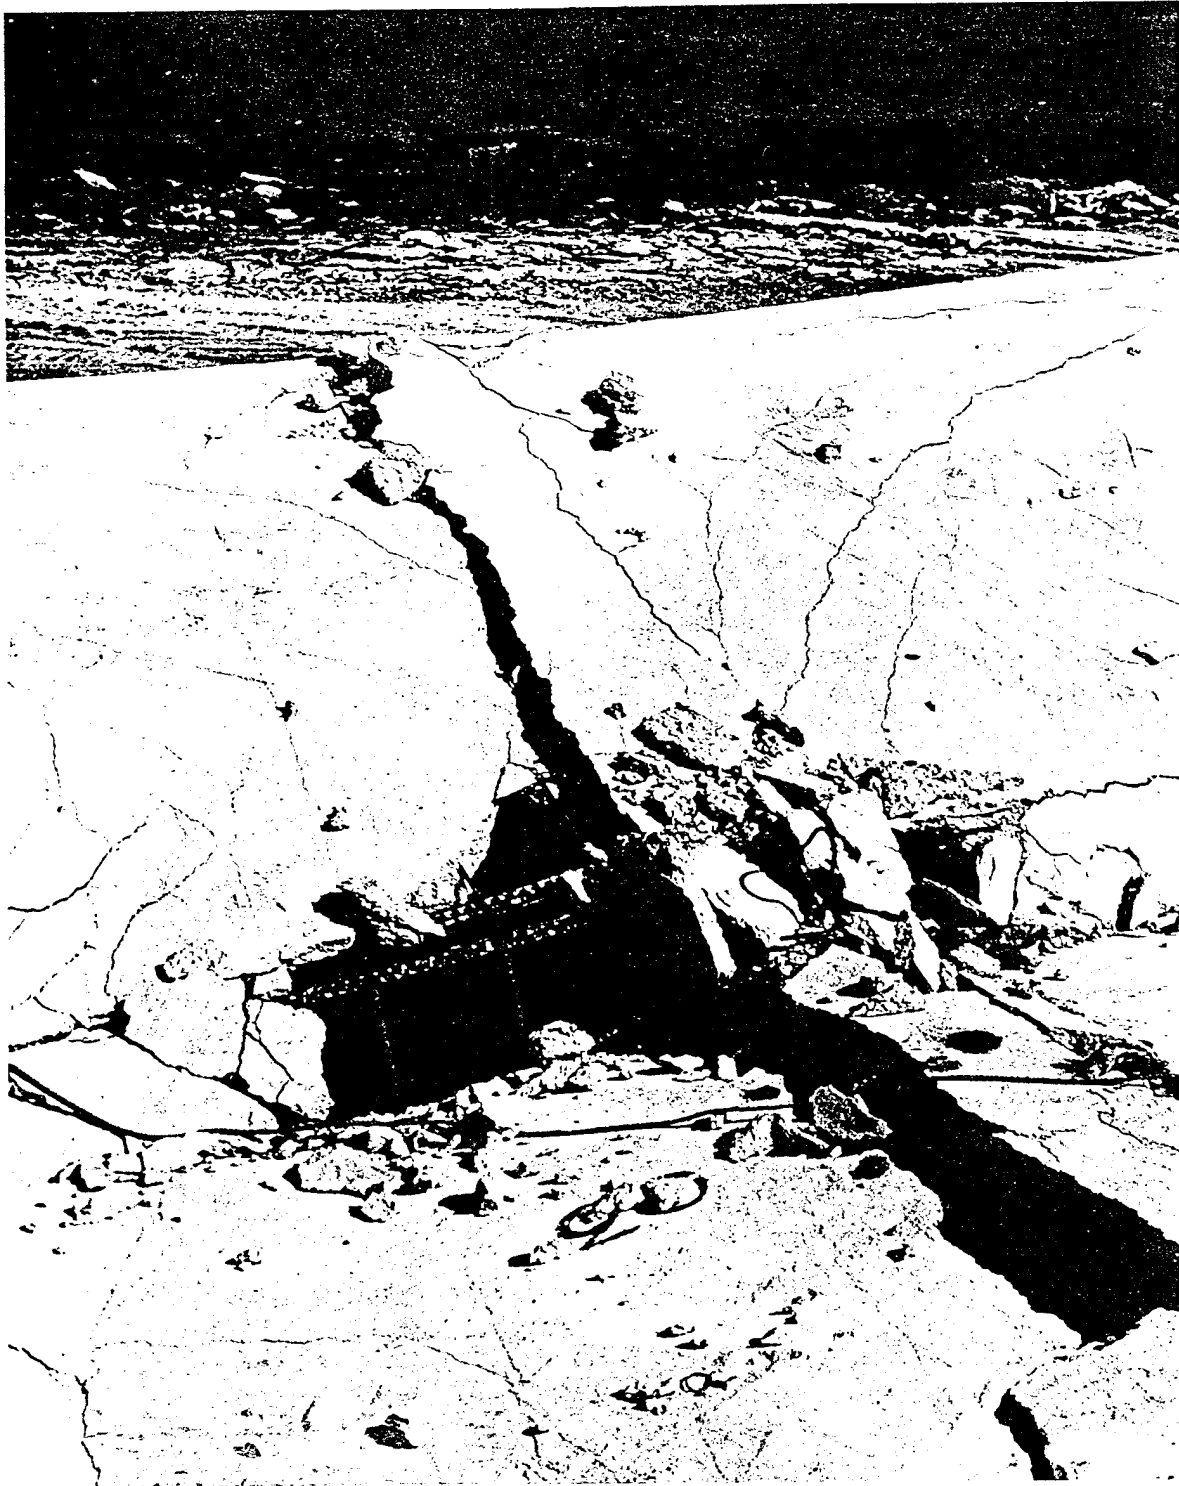
Fig. L. 508 Detail View of Concrete Failure along Main Transverse Roof Girder, Structure 3.2. 7b. Reinforcing steel has elongated but has not ruptured.
